IRAQI C-130 BASE
BAGHDAD, IRAQ

SUSTAINMENT ASSESSMENT

SIGIR PA-07-099
JULY 24, 2007

SUBJECT: Report on Sustainment Assessment of the Iraqi C-130 Base, Baghdad, Iraq
(Report Number SIGIR PA-07-099)

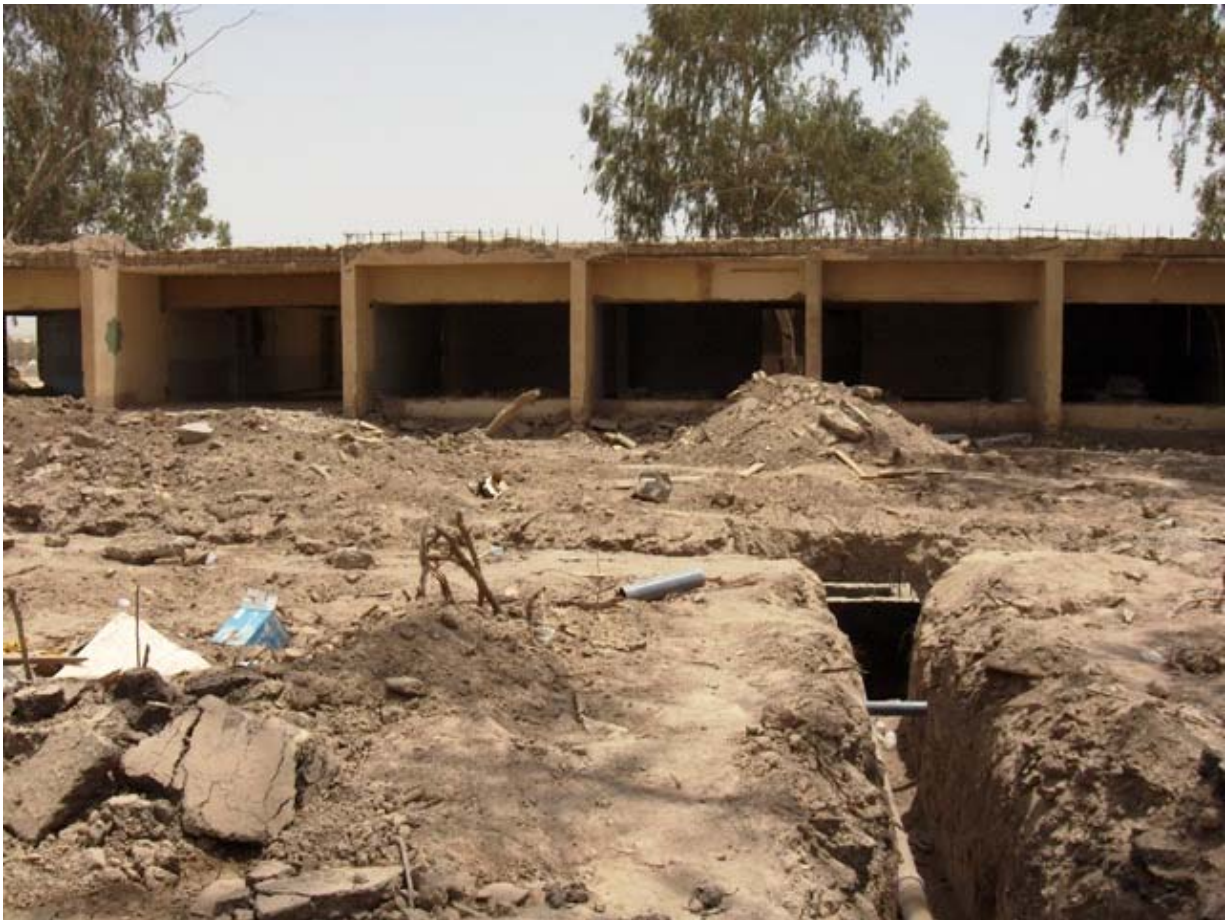
Site Photo 1. Pre-construction state of building B-230 front view. Extensive renovation work needed. (Contractor provided photo)

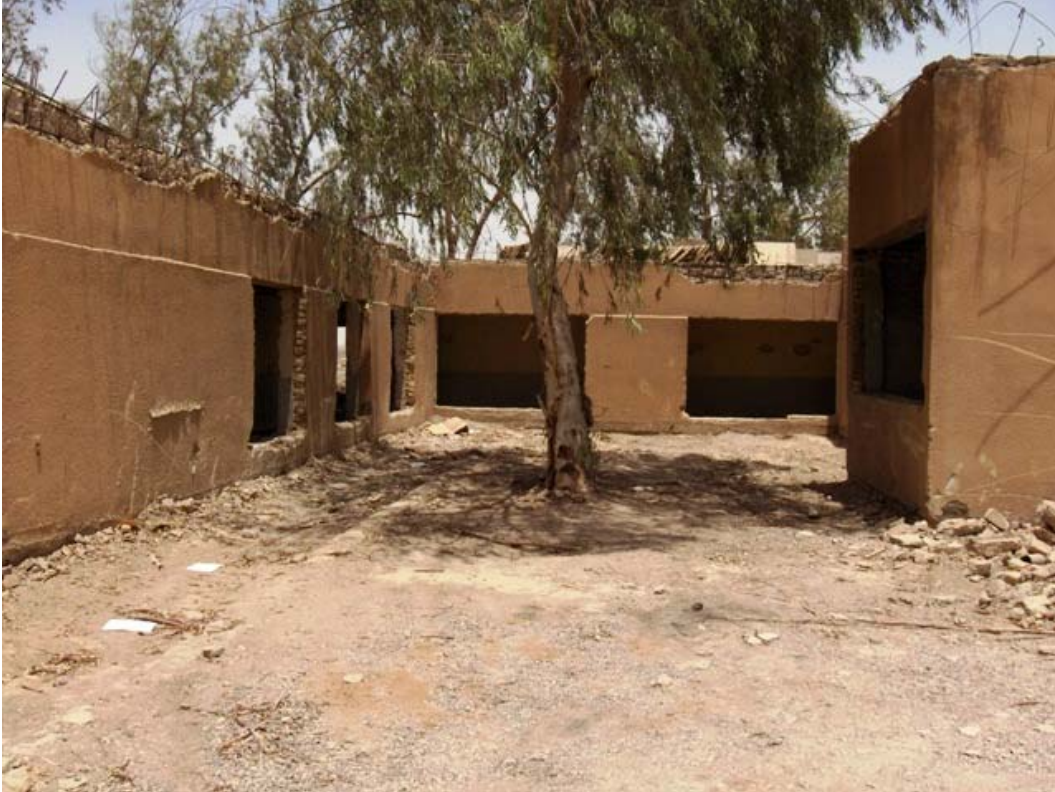
Site Photo 2. Pre-construction state of building B-230 courtyard, extensive renovations needed. (Contractor provided photo)

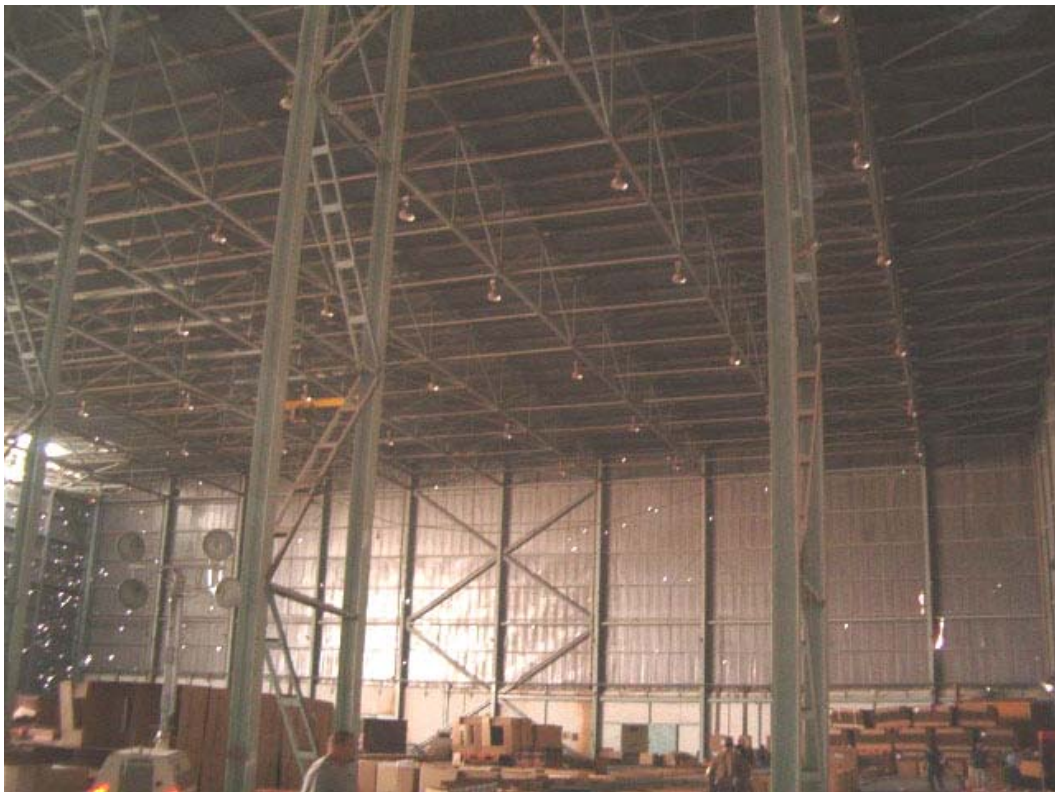
The largest structure in the renovation, the aircraft hangar that measures 80.55 meters by 135.86 meters, is shown in Site Photo 3. The pre-construction hangar needed new metal sheeting and roofing as well as renovation of the attached surrounding offices.

Site Photo 3. Pre-construction state of the hangar B-260, replacement metal needed on walls and roof. (Contractor provided photo)

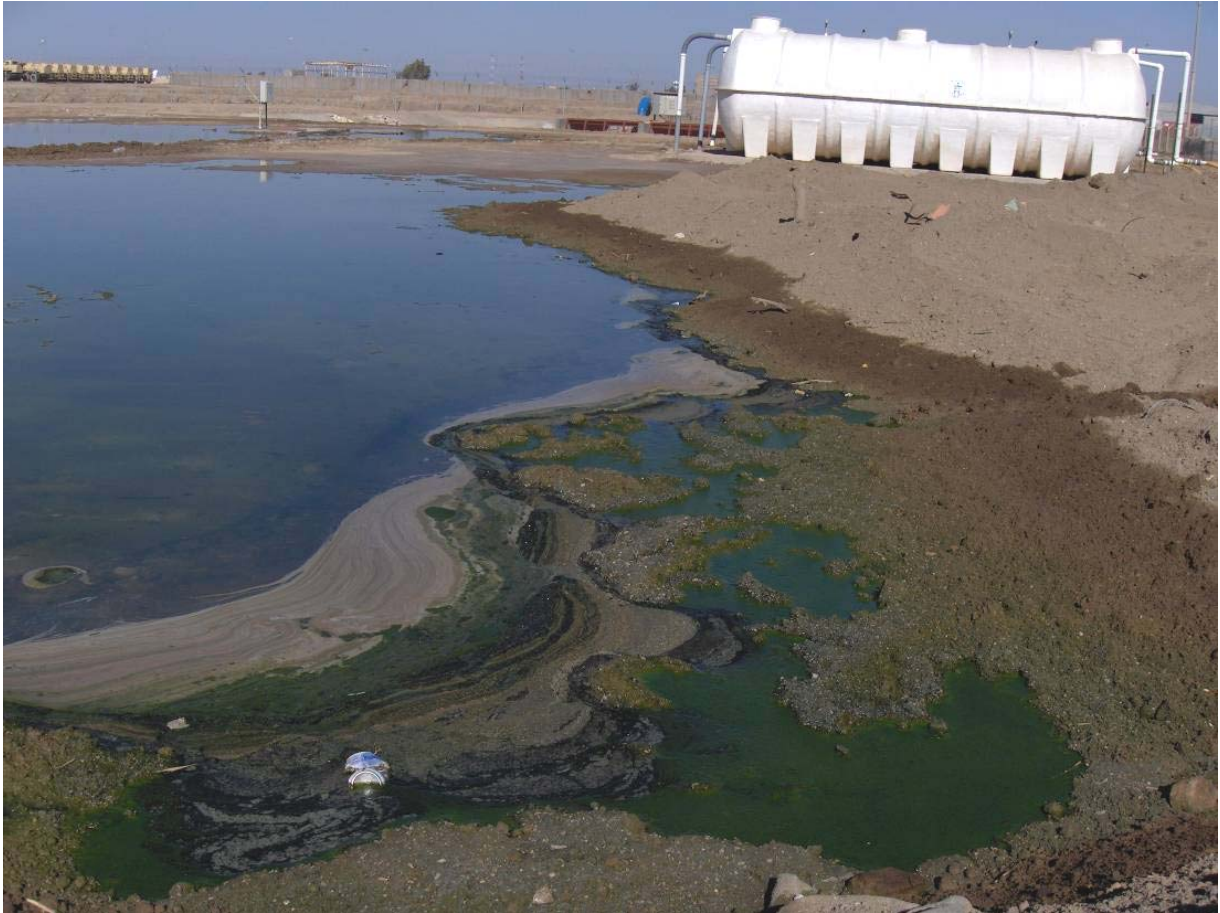
The sewer holding tanks were not sufficiently pumped. Routine tank O&M did not appear to be effectively performed. The prime contractor documented the overflow issue with pictures and an email regarding a discussion with the O&M contractor. The resulting sewage puddle overflowed to the storm water collection pond. Site Photo 4 shows sewage overflow on 24 February 2006. The issue was resolved when adequate pumping was reinstated as a result of the prime contractor and MNSTC-I intervention.

Site Photo 4. Sewage overflows around the holding tanks. (Contractor provided photo)

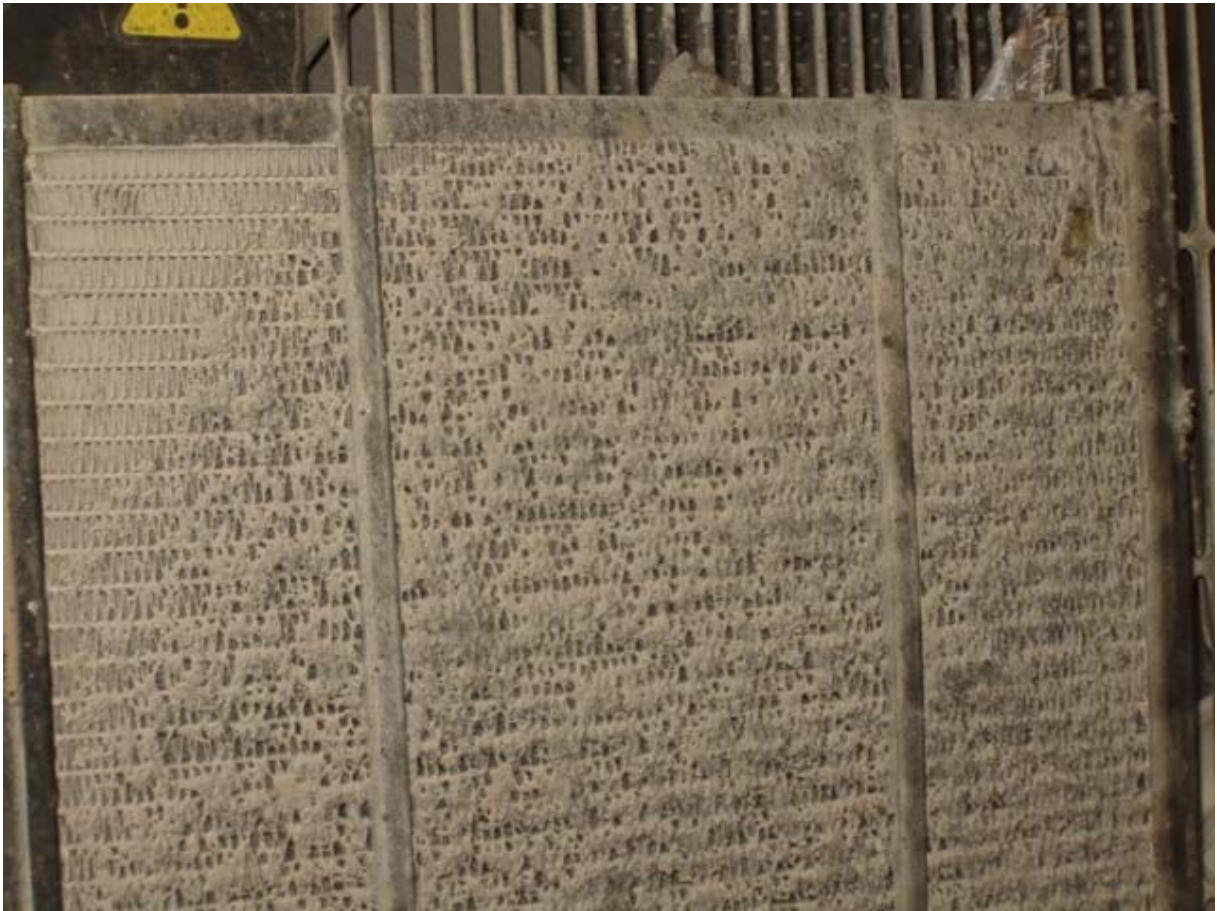
In Site Photo 5, the contractor documented dust plugging the screen of a generator radiator. Additionally, feathers and dirt plugged the inline fuel filters of a generator. Both these conditions were the result of poor O&M practices. After a warranty report for a generator at building 277 that was completed on 2 December 2005, the contractor checked the maintenance logs and documented¹ that the recommended O&M was not being performed on any of the generators. The lack of proper O&M resulted in generator failure and the contractor being asked to perform warranty work on items that were not being maintained.

Site Photo 5. Generator radiator screening filled with dust. (Contractor provided photo)

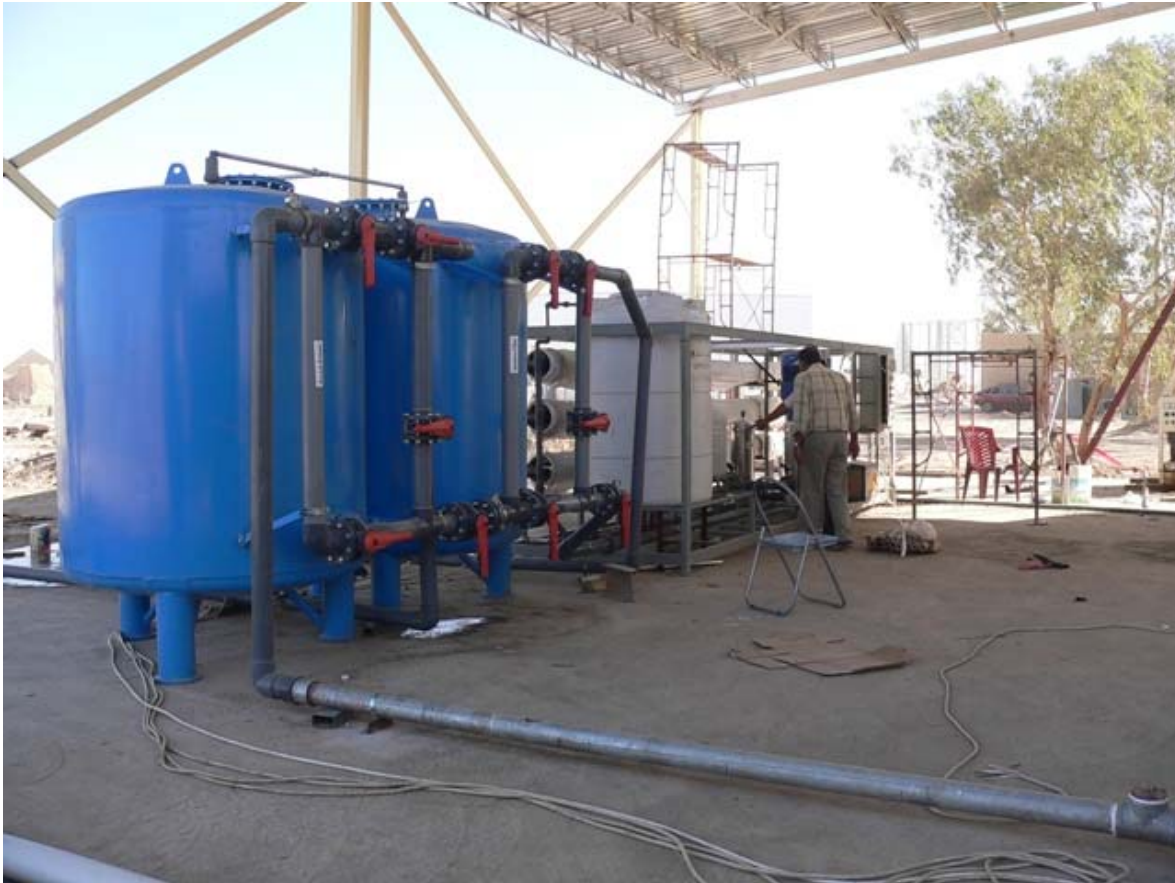
In February 2006, the contractor documented that the reverse osmosis (RO) unit had no spare filters, anti-scaling chemical, testing kits, and other various maintenance items available on site. The contractor also reported that regular filter changes had not been performed, the chlorine dosing did not meet requirements, and the RO system pressures were not within the recommended range. This likely occurred because the recommended O&M was not being performed on the RO unit. This caused the RO unit to malfunction with a possibility of damage to the RO membranes. Poor O&M on the RO unit directly impacted water quality.

Site Photo 6. Reverse osmosis unit at installation. (Contractor provided photo)

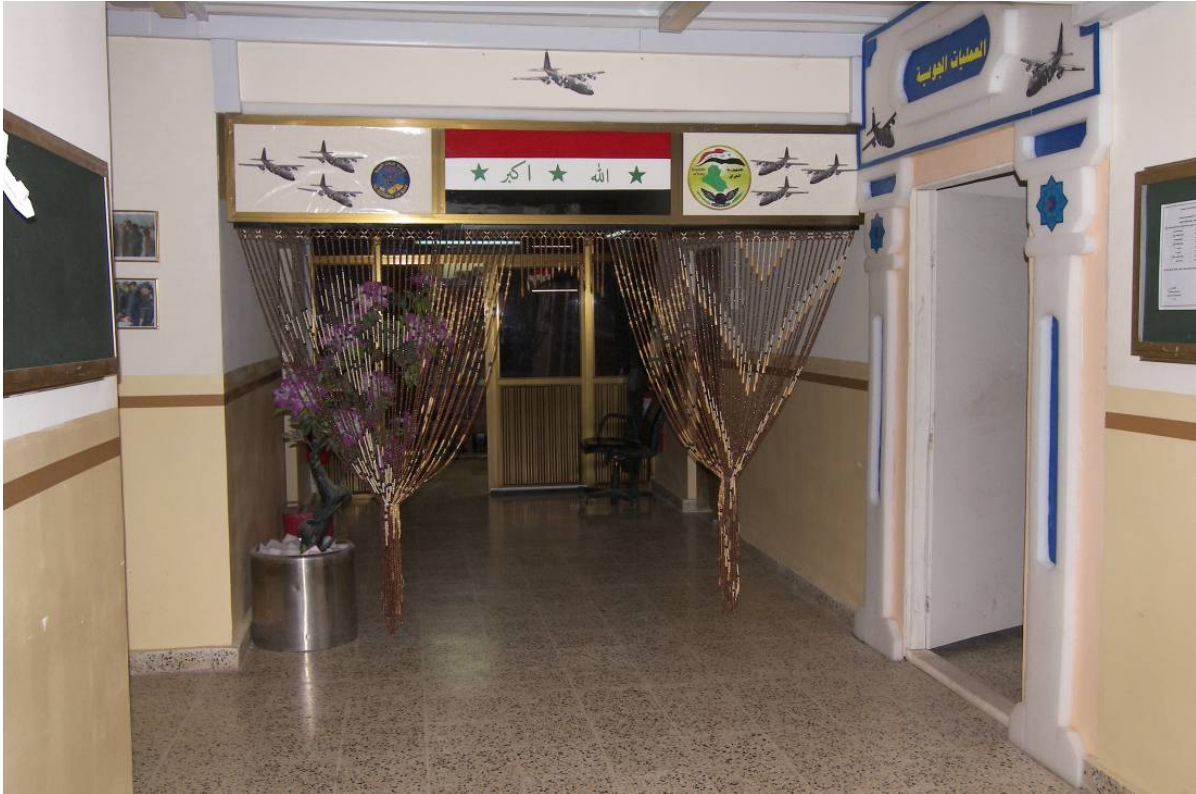
For example, in the headquarters building (base support offices B-300), (Site Photos 7 and 8) the interior construction remained fully functional and well maintained. SIGIR noted that although the Iraq Air Force occupied the headquarters building, items such as paint, sockets, switches, electrical wiring, doors, and floor tile work remained, most work appeared new and fresh. The building air conditioning and electrical components also worked well.

Site Photo 7. Headquarters building (B-300) appeared in good condition at the time of the site visit.

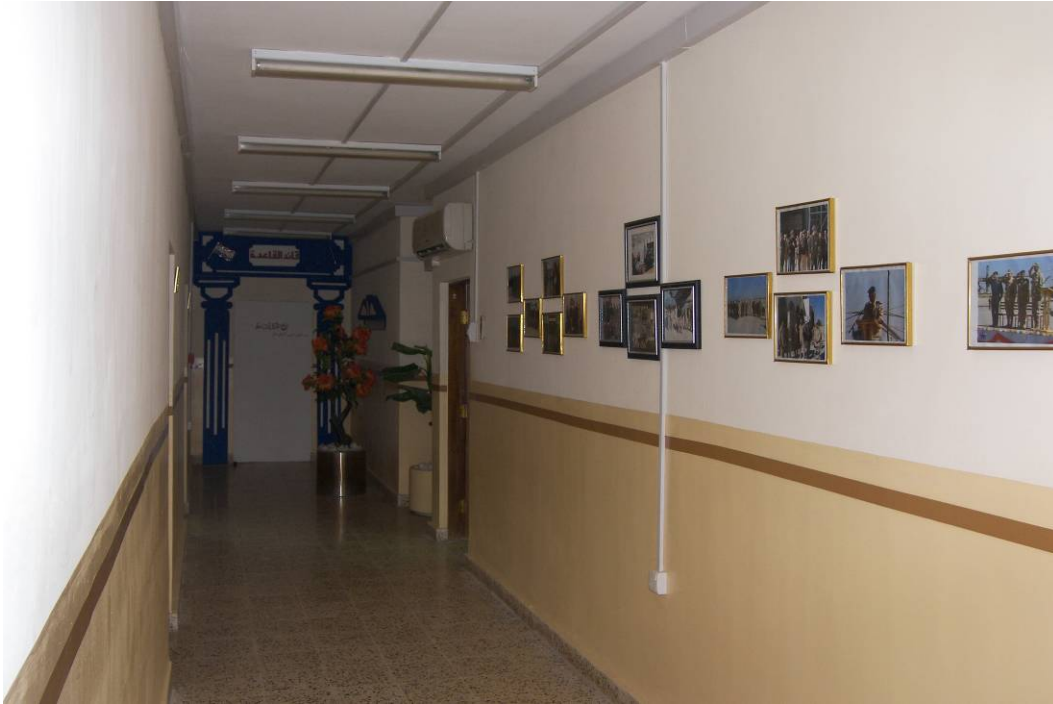
Site Photo 8 Headquarters building hallway was well maintained

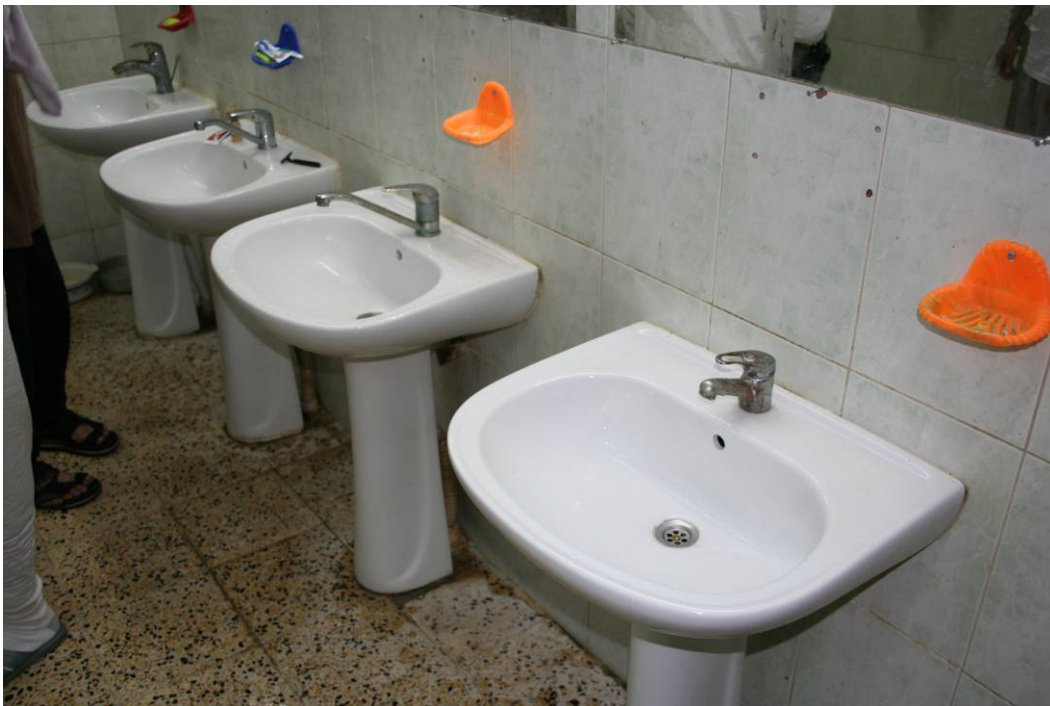
SIGIR visited the base barracks as part of the inspection. Site Photo 9 shows the sinks in the barracks bathroom. The bathroom sinks, showers, and toilets all worked at the time of the visit. Additionally, bathroom tile work, suspended ceiling, lights, mirrors, and shower doors all appeared to be in good condition.

Site Photo 9. Barracks bathroom in functional condition. Tile work, floors, sinks, and mirrors appeared in good condition.

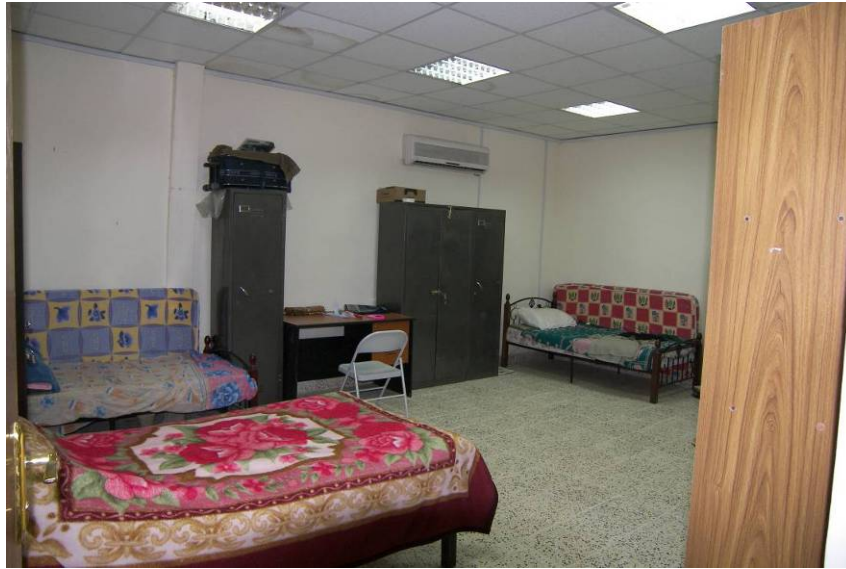
Site Photo 10. Barracks bedroom

Site Photo 10 shows a base barracks bedroom in relatively good condition.

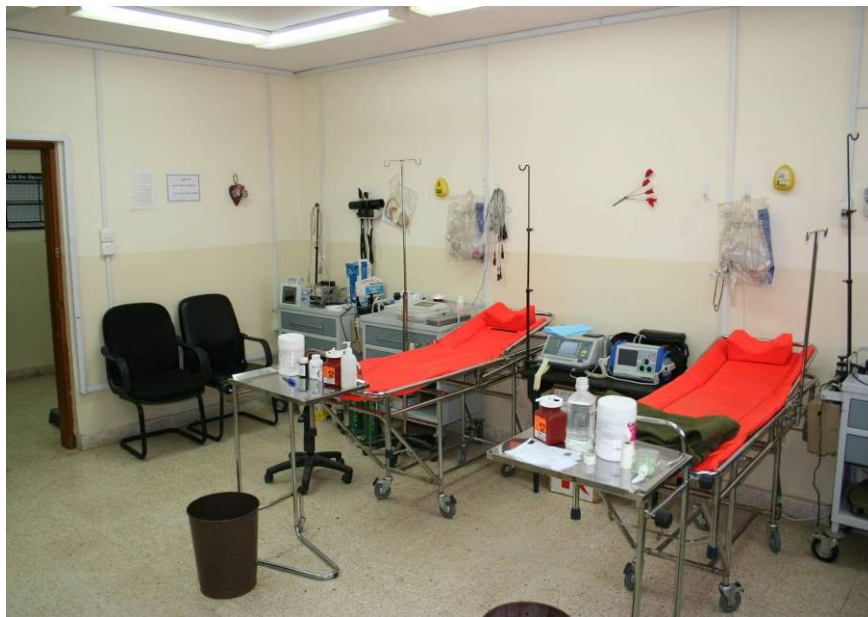
Site Photo 11. Base clinic emergency room

SIGIR found the base clinic to be a well-maintained facility with overall good construction. In Site Photo 11, the clinic emergency room appeared clean and well organized, with a working electrical system. Bathrooms, exam rooms, offices, pharmacy, dental room, laboratory, patient room, and other sections of the clinic were in similar condition.

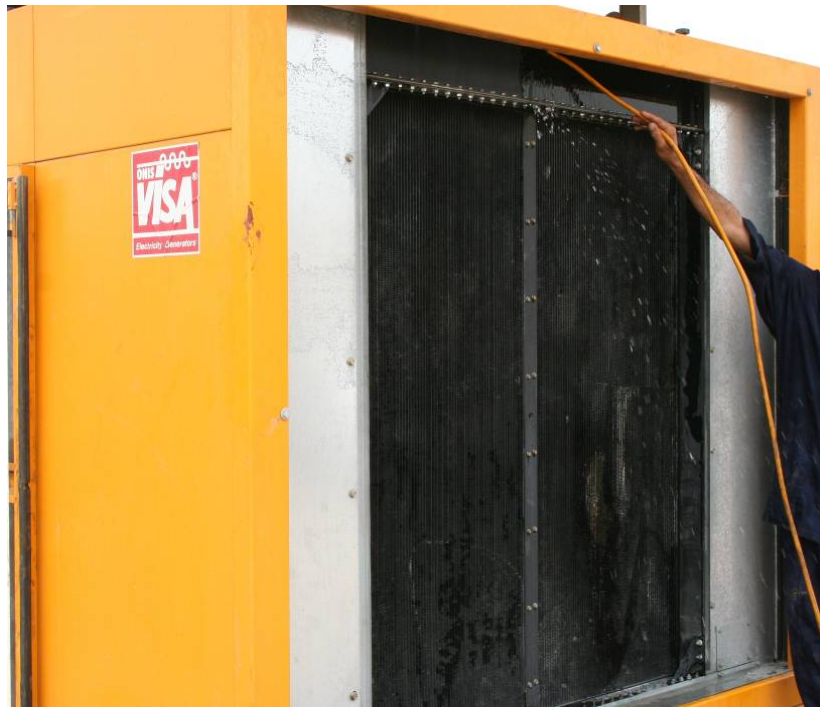
The working generators appeared clean and the inoperative generators contained adequate oil. During SIGIR's visit, a worker sprayed one of the operating generator's radiator with a water hose (Site Photo 12). According to the worker's supervisor, the water was employed to cool the radiator. Water on the ground and on the radiator prevented inspectors from observing any possible coolant leak from the radiator.

Site Photo 12. Worker cools a running generator with water.

Poor O&M was the primary cause of the generator's poor condition. This situation was compounded by resource issues. One of the generators had parts removed but not replaced. Discussions with MNSTC-I personnel verified that supply and distribution issues exist in the Iraqi supply system. Poor O&M practices on the generators will eventually result in sustainability problems as failures occur.

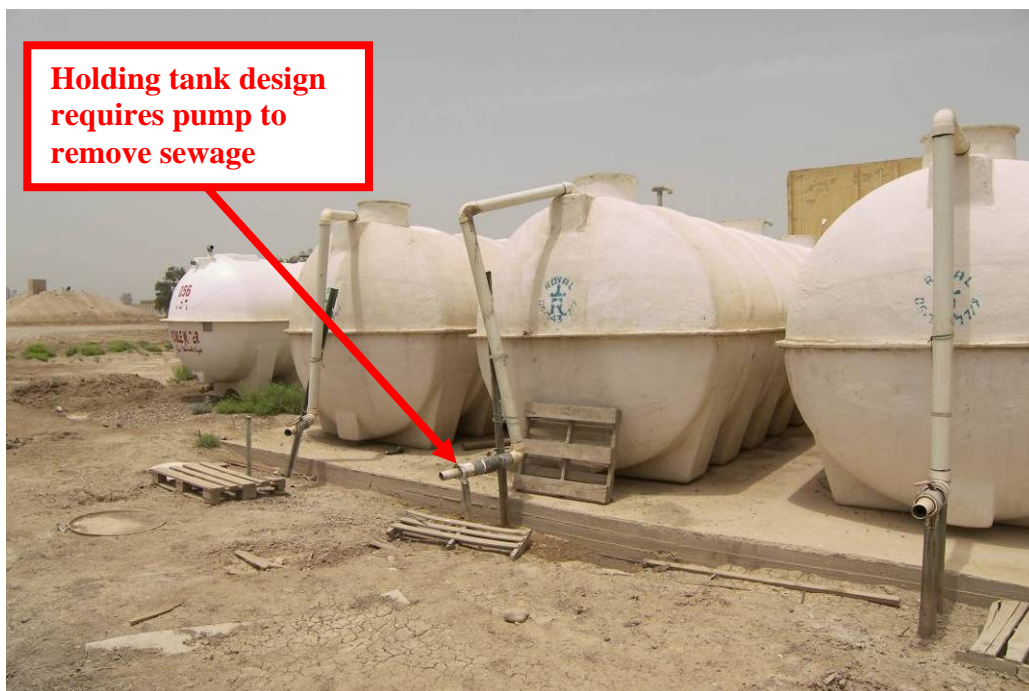
The contractor designed the sanitary sewer system for a capacity of 400 occupants at a rate of 200 liters per person per day as specified by the contract in section 2.1.9.2. The design called for a complete sanitary sewer system. The contractor's design incorporated a gravity drain and five lift stations which pump into three above ground sewer storage tanks as shown in Site Photo 13.

At the time of the SIGIR site visit, the sanitary sewer collection system functioned. SIGIR noted that the sewer collection tanks were empty. The ground by the tanks contained recent truck tracks and wet sewage overspill was evident in the dirt in front of the tanks. Conversations with an on-site contractor performing a site assessment for MNSTC-I verified that the sewer indeed functioned.

Site Photo13. Three sewage holding tanks designed to be pumped out.

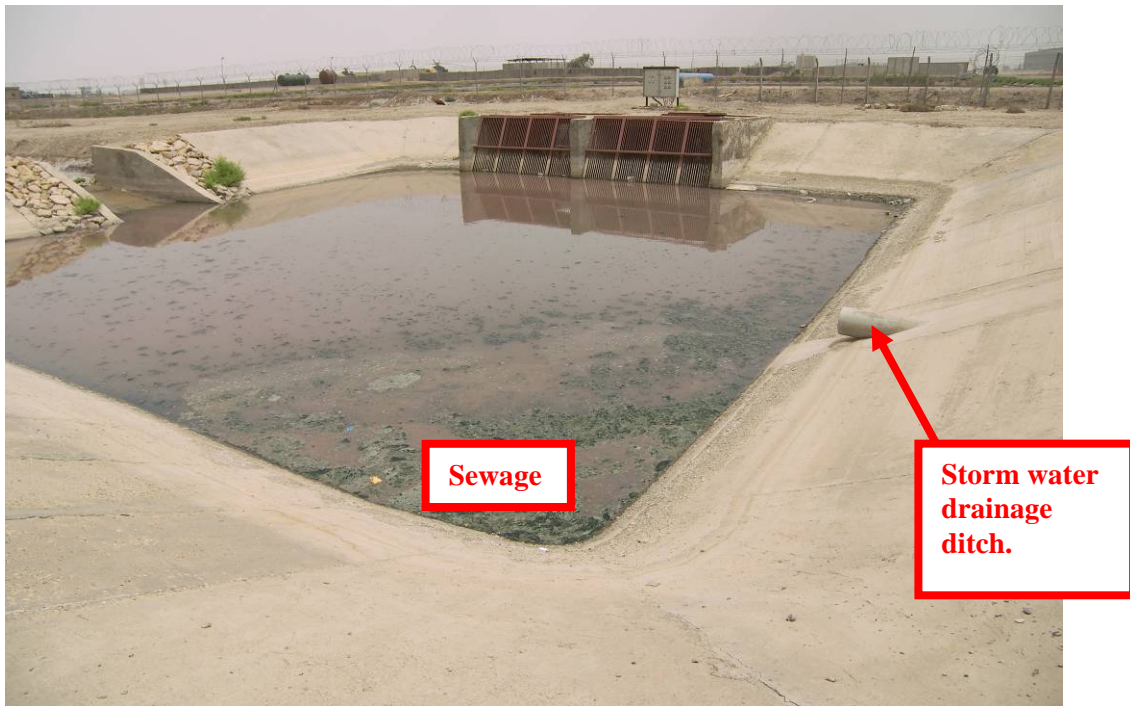
Raw sewage filled the storm drainage collection pit (Site Photo 14) and connecting drainage ditch (Site Photo 15). A small wet soil trail was evident in the soil in front of the sewage tanks to the drainage ditch, where it appeared that a hose leaked. The holding tank design only allows sewage removal by pump. Waste removal required a pump truck to transfer sewage from the collection tanks to the drainage ditch. From the evidence on site, the inspectors concluded that the pump trucks were used to pump the holding tanks into the drainage ditch.

The lack of O&M on the sanitary sewage system resulted in reduced performance of the storm overflow system and also caused a potential health hazard.

Site Photo 14. Storm drainage collection pond containing raw sewage.

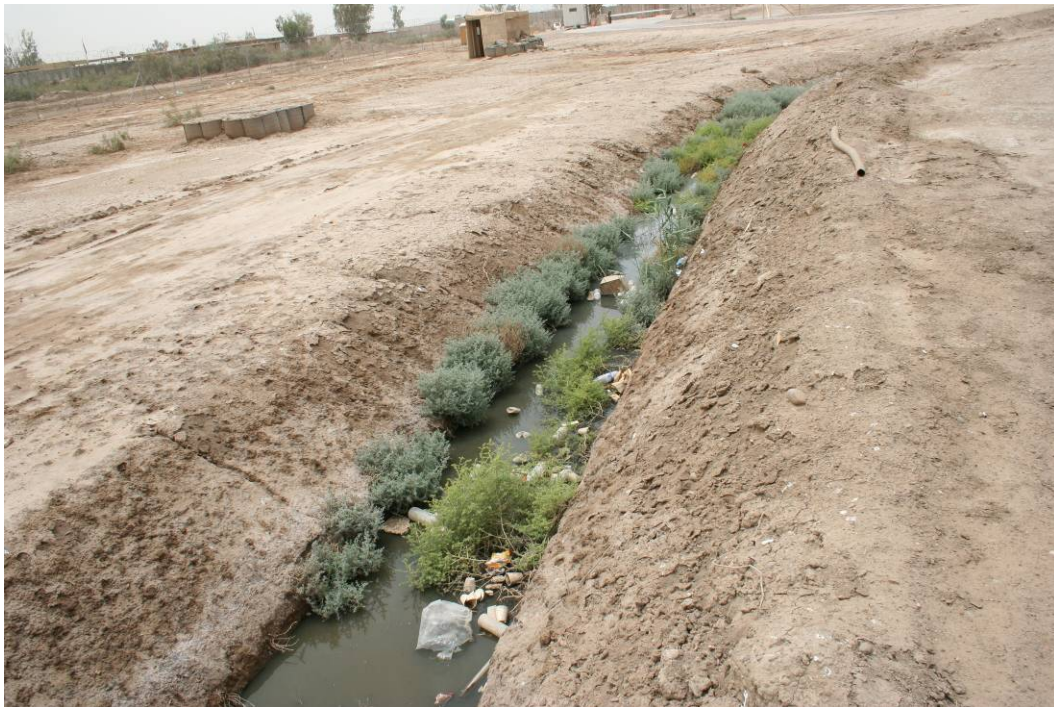
Site Photo 15. Raw sewage is pumped from sewage holding tanks into storm water runoff ditch

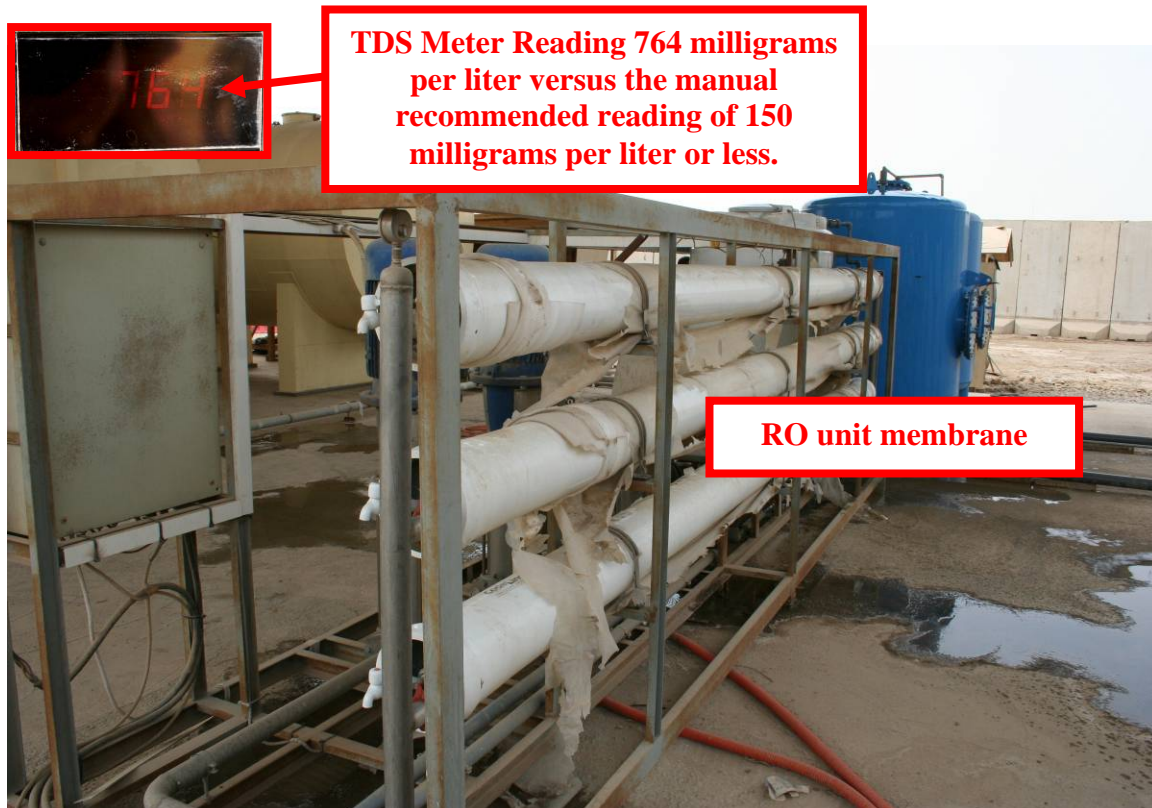
SIGIR noted that the RO produced water outside of the recommended total dissolved solids (TDS) range by a factor of five. The TDS meter read a TDS of 764 milligrams per liter, while the O&M manual recommended a reading of 150 milligrams per liter or less (Site Photo 16).

The RO maintenance worker stated that the permeators (the reverse osmosis membrane elements) were "no good". According to the O&M manual, the permeators only require periodic cleaning and fouling is the primary reason for permeator destruction.

The deteriorated condition of the RO unit was due to the lack of O&M. No records of current water tests, filter changes, periodic readings, chemical tank fillings, or other O&M activities were available. This could, be in part, a resource issue. No replacement filters were available at the time of the inspection. Spare parts were not readily available on site. The maintenance supervisor stated that only the base's general officer could grant access to, or order spare filters and replacement parts.

Site Photo 16. RO unit malfunctioning.
